AIRCRAFT ACCIDENT REPORT

PAN AMERICAN WORLD AIRWAYS, INC
BOEING 707-121, N709PA
NEAR ELKTON, MARYLAND
DECEMBER 8, 1963

SYNOPSIS

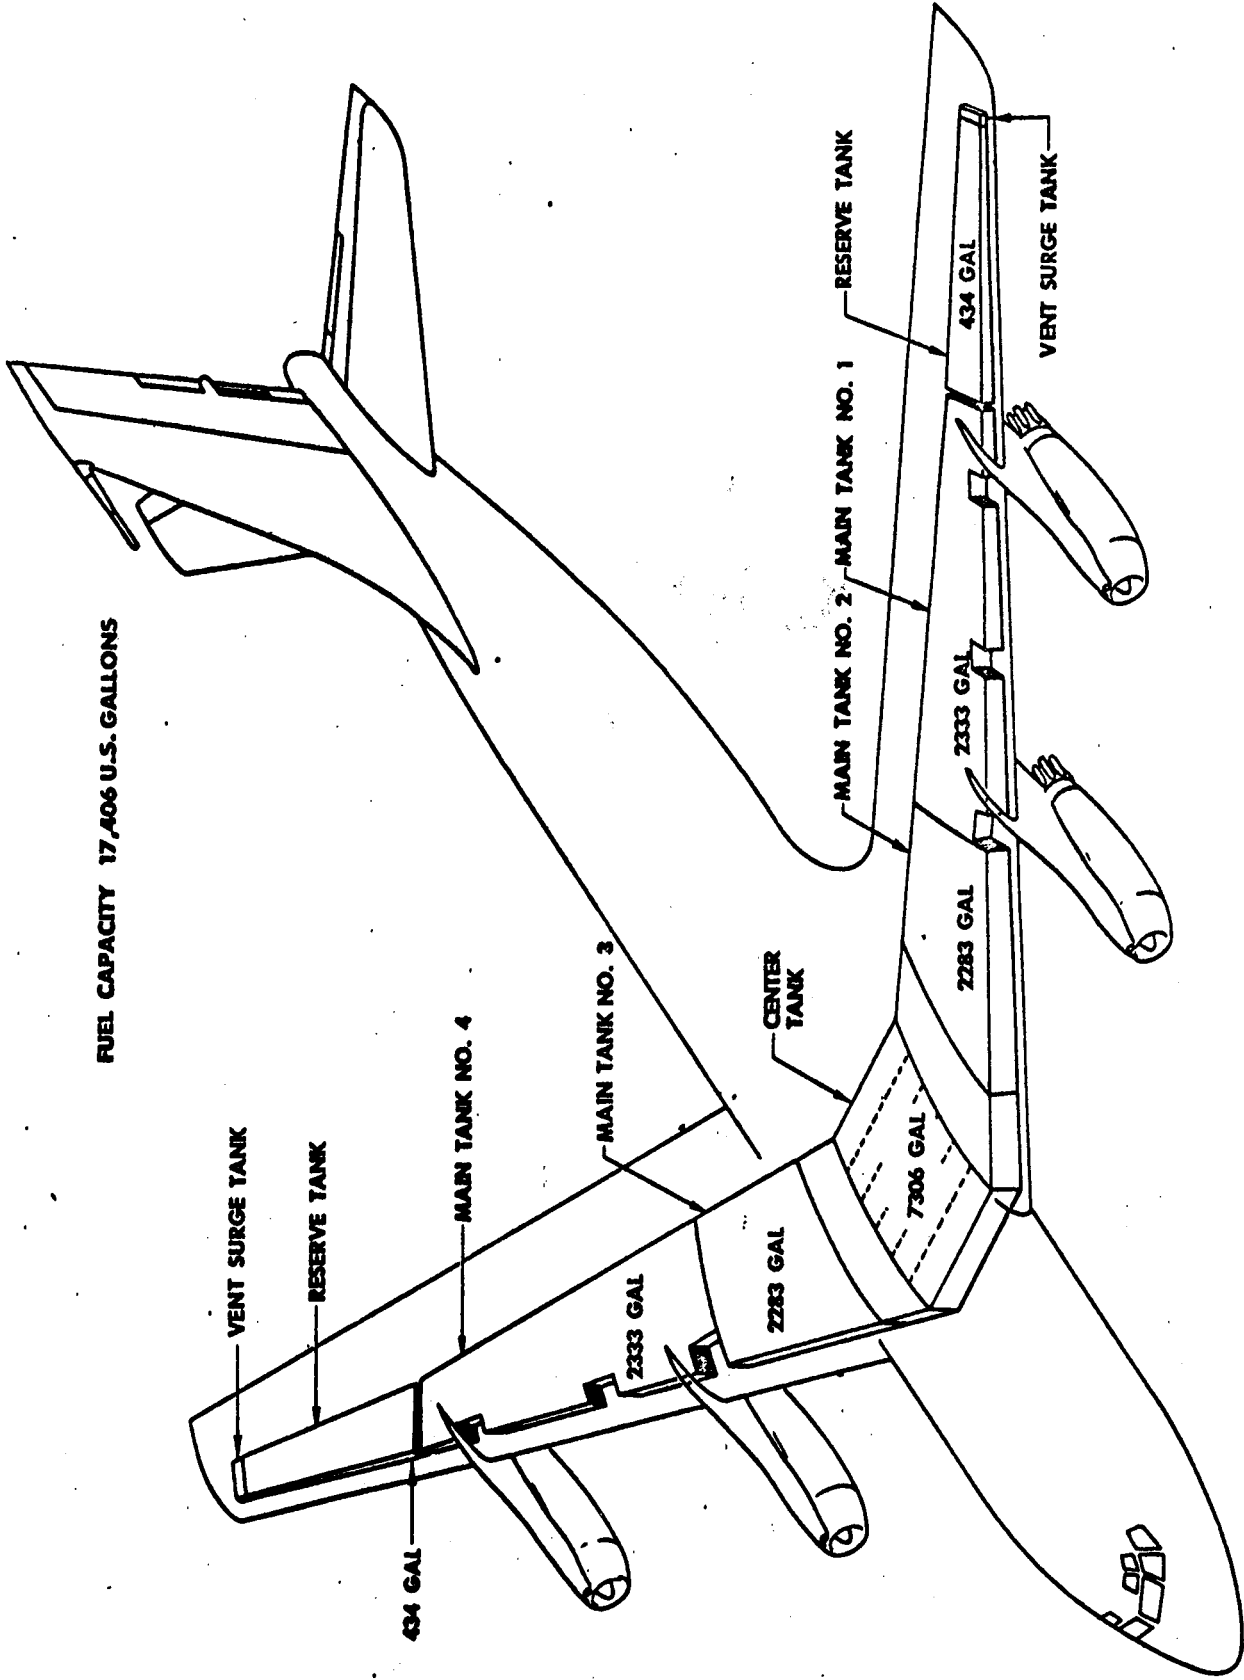
FUEL TANK ARRANGEMENT
28-6 REV C

The surge tank box^{7/} was intact except for a 2.2 inch opening along the top extending from spar to spar. This opening encompassed the surge tank end of the vent passages from the fuel tanks. The ends of the fracture curled up and were moderately sooted. The bottom surge tank skin was curled downward at a fracture line along the tank end closure rib. Very slight outward bulging of the tank end rib was noted. The interior of the surge tank was heavily sooted on all sides and the sealant was burned inside.

A 27-inch section of the forward spar was bulged outward and the bottom spar cap was bulged downward. There was slight sooting or discoloration on the reserve tank side of the spar and slight charring of the sealant at the juncture of the spar and the closure rib.

The center tank ^{8/} bottom skin was separated in three pieces. Stiffeners and access doors were bowed outward. The largest section was bowed chordwise in an outward direction. There were no signs of fire damage.
